⑨ National Dam Inspection Program. Mill Run Dam (NDI ID 533), Susquehanna River Basin, Mill Run, Blair County, Pennsylvania. Phase I Inspection Report.

MILL RUN DAM

NDI I.D. NO: 533

PHASE I INSPECTION REPORT
NATIONAL DAM INSPECTION PROGRAM

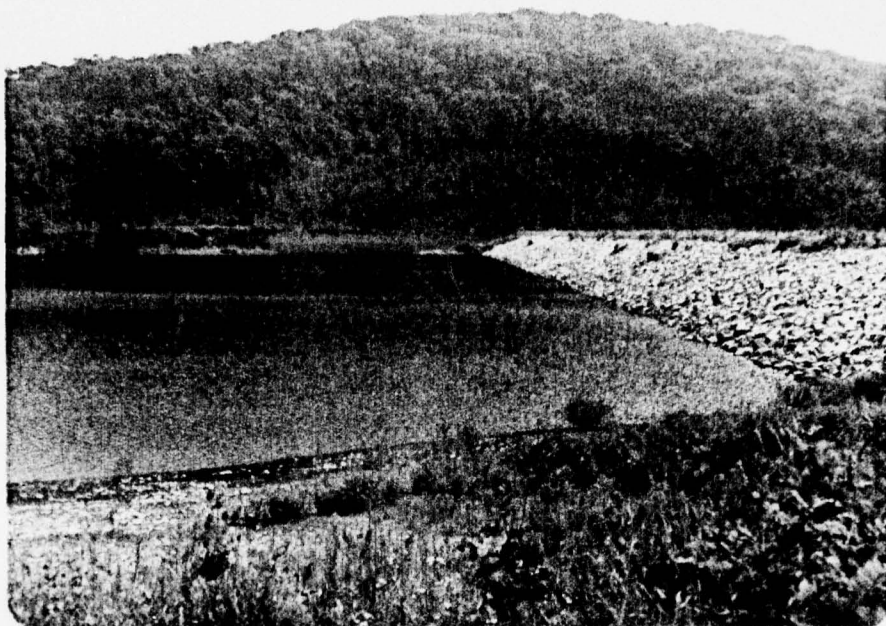
Upstream Face

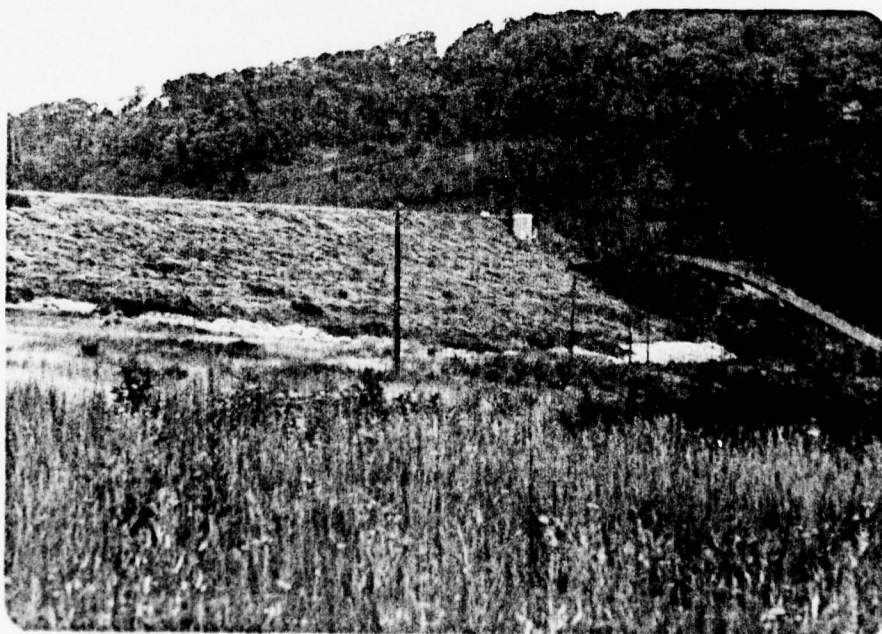
Downstream Face

2. High crown vetch precluded the inspection of the downstream slope of the dam for surficial signs of distress, such as cracks or wet areas.

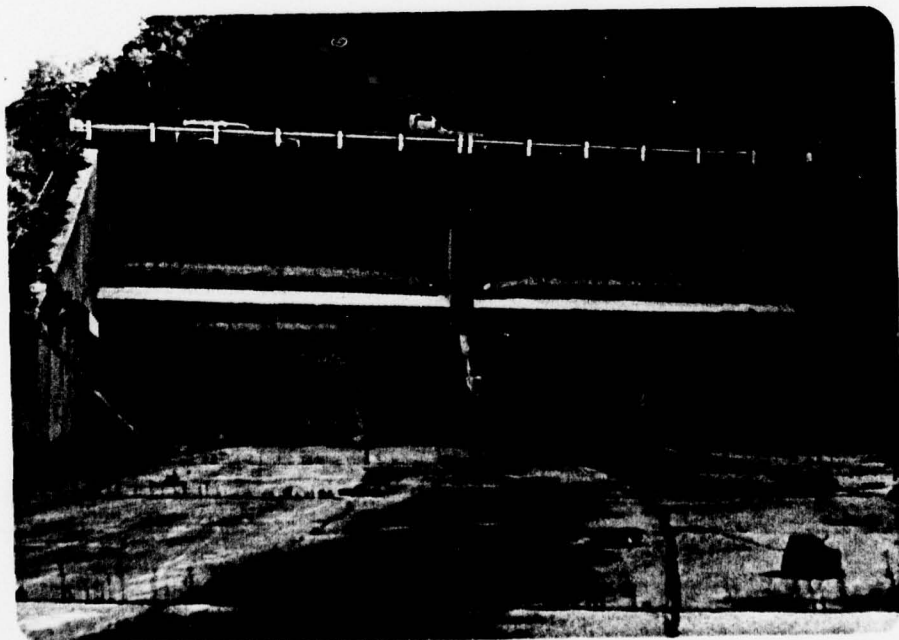
Photograph No. 2
Spillway crest (note inflatable spillway gates).

Because sudden release of water in the event of a failure of the Fabridam spillway gates may cause property damage downstream and because of the unique nature of these gates, this appurtenance should be frequently inspected by personnel experienced in design, construction, maintenance, and operation of such equipment.

The inflatable gates were inflated by the authority personnel and were found to be functional. The maintenance condition of the control equipment for the gates is considered to be satisfactory. However, because a sudden release of water in the event of a failure of the spillway gates may cause property damage downstream by overflowing the channel on a residential area of Altoona and considering the unique nature of the Fabridam spillway gates, it is considered advisable that these facilities be periodically inspected by engineers experienced in design and installation of such equipment.

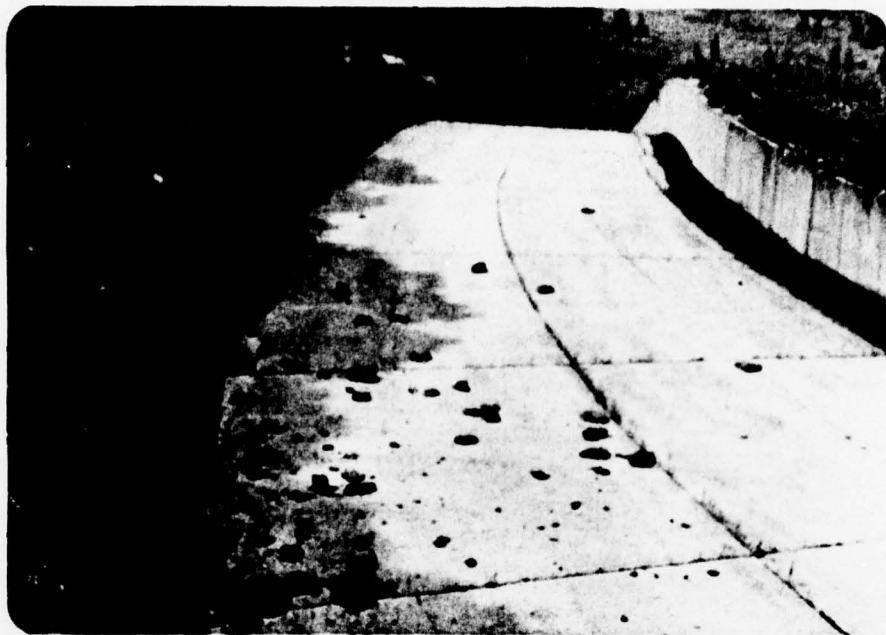
Photograph No. 3

In general, the structures were found to be in good condition. However, a steep rock cut along the spillway approach channel and discharge chute is considered to pose a potential for partial blockage of these channels in the event of a significant rock slide. Boulders in the approach channel and spillway chute demonstrate this potential.

Spillway discharge channel (note fallen rocks from rock cut).

It is recommended that seepage from the sand drains be monitored and recorded. The steep rock cut along the spillway should be frequently observed and necessary remedial measures taken to prevent rock slides that may partially block the spillway channel.

1. It is recommended that seepage from the sand drains be monitored and recorded.
2. The steep rock cut along the spillway channel should be frequently observed and necessary remedial measures taken to prevent rock slides that may partially block the spillway channel.
3. Due to the unique nature of the Fabridam spillway gates and since a sudden release of water in the event of their failure may cause property damage downstream by overflowing the channel in a residential area of Altoona, this appurtenance should be frequently inspected by personnel experienced in design, construction, maintenance, and operation of such equipment.
4. It is recommended that the owner provide around-the-clock surveillance during periods of unusually heavy runoff and develop a formal warning system to alert the downstream residents in the event of emergencies.

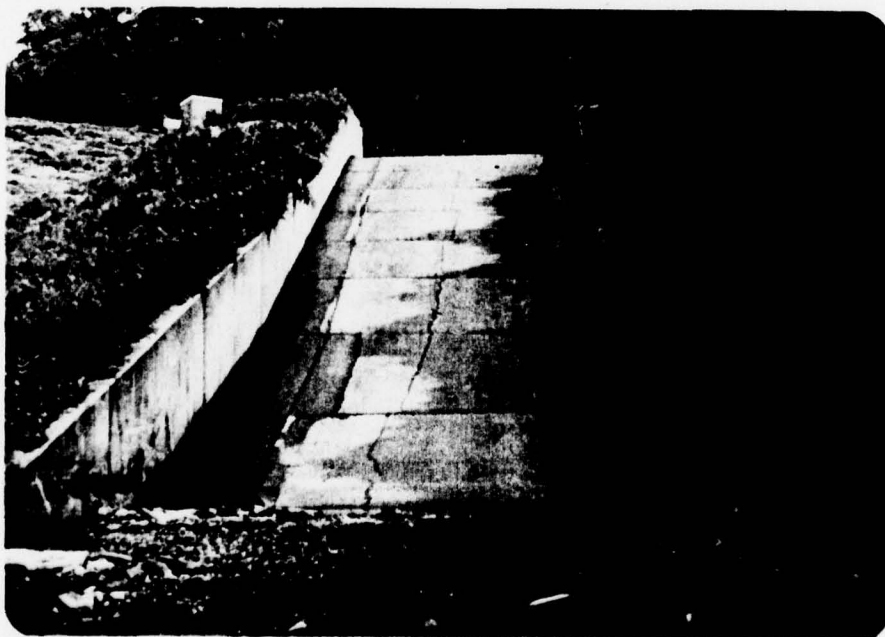
Photograph No. 4

Spillway discharge channel and plunge pool.

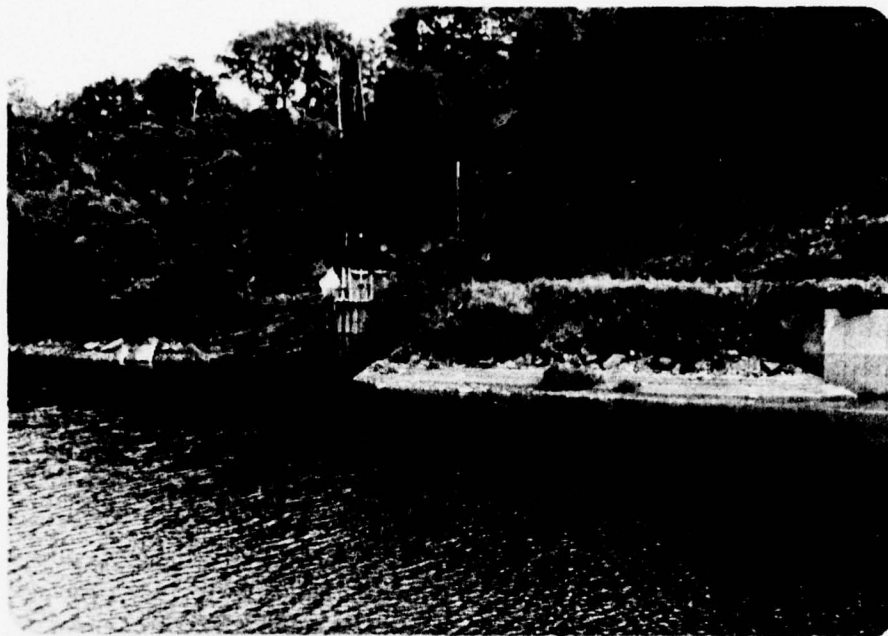
Photograph No. 5
Intake tower.

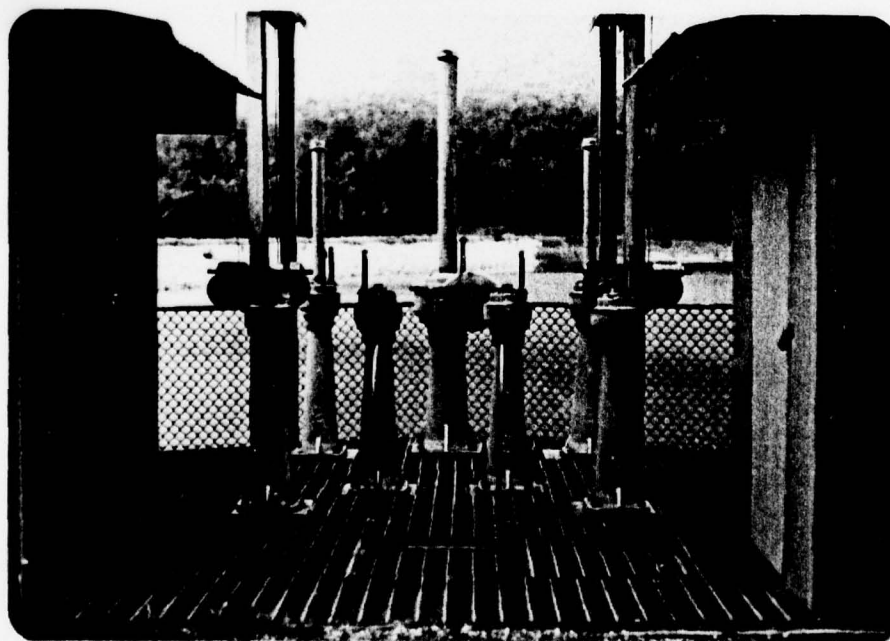
Photograph No. 6
Intake tower gate controls.

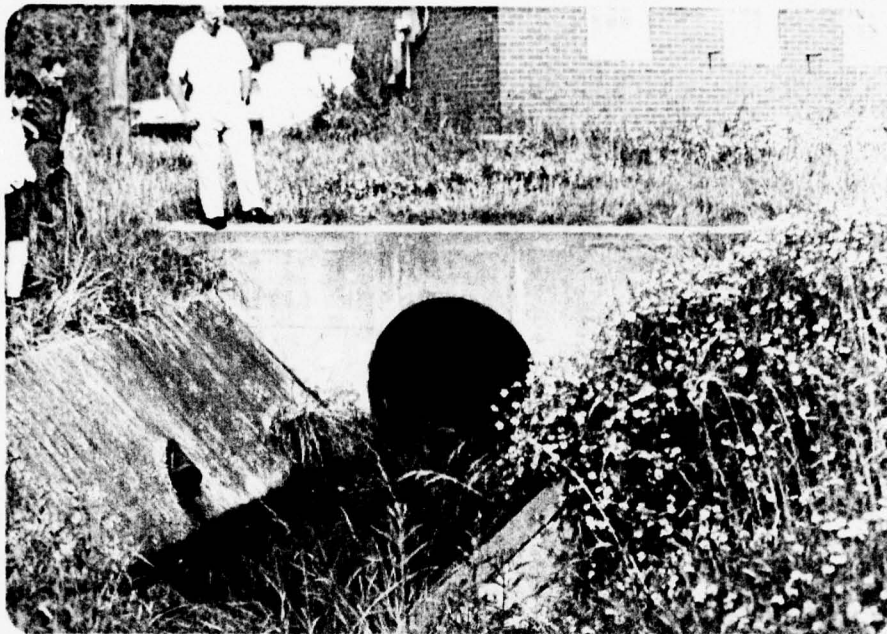
4.3 Maintenance of Operating Facilities. The maintenance condition of the operating facilities is considered to be satisfactory. The drainpipe valve for the lake was operated and observed to be functional. The control equipment for the Fabridams was observed and found to be in satisfactory condition.

Photograph No. 7
Lake blow-off pipe.

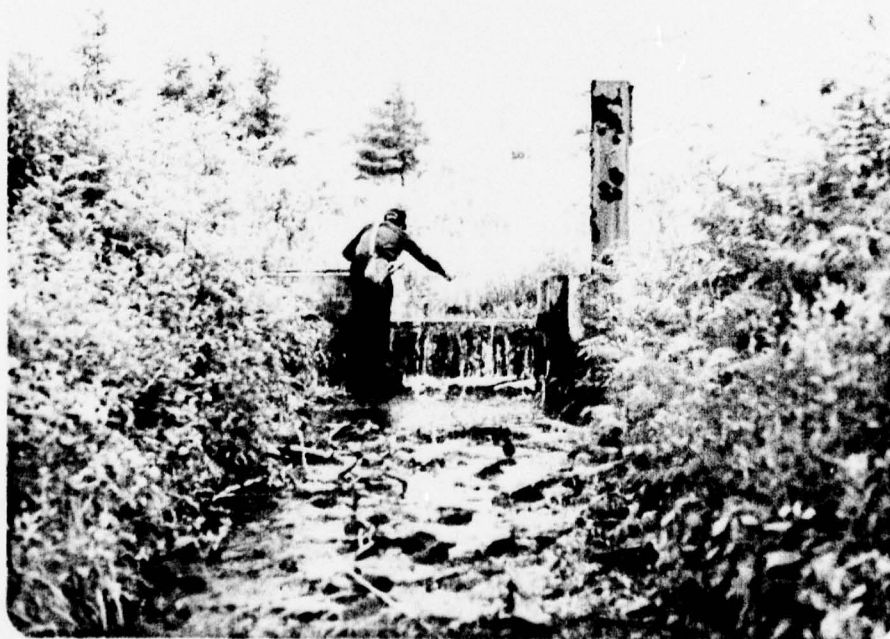
1. Except for one seepage area which discharges into the spillway discharge channel immediately downstream of the plunge pool, all seepage observed at the site is collected by a drainage system discharging into the blow-off pipe channel. Flow from the blow-off pipe discharge channel was determined to be 150 gallons per minute on the date of inspection from a measurement taken at an existing rectangular flow weir.

VISUAL EXAMINATION OF	OBSERVATIONS	REMARKS OR RECOMMENDATIONS
MONUMENTATION/SURVEYS	NONE FOUND	
OBSERVATION WELLS	NONE	
WEIRS	ONE FLOW WEIR ON OUT LET PIPE DISCHARGE CHANNEL. REMOTE RECORDING EQUIPMENT NON-FUNCTIONAL	IT IS REPORTED THAT FLOW READINGS ARE NOT BEING TAKEN.
PIEZOMETERS	NONE	
OTHER	NONE

Photograph No. 8
Seepage weir.

4.2 Maintenance of the Dam. The general condition of the dam is considered to be satisfactory. However, it is considered necessary to resume monitoring seepage flows from the sand drains to determine that the rate of flow is not increasing with time.

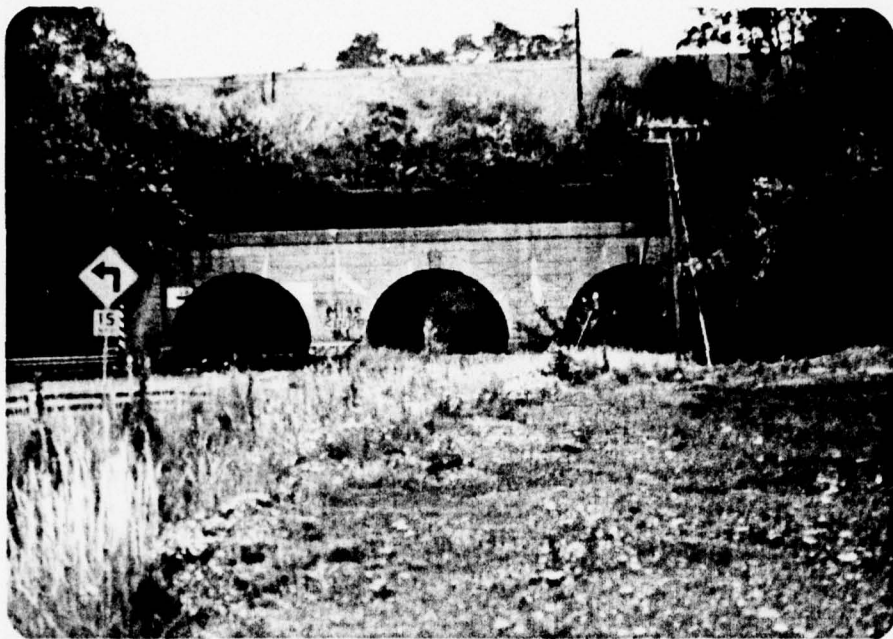
Photograph No. 9

Penn-Central Railroad embankment (2 miles downstream;
stream flows through middle arch).

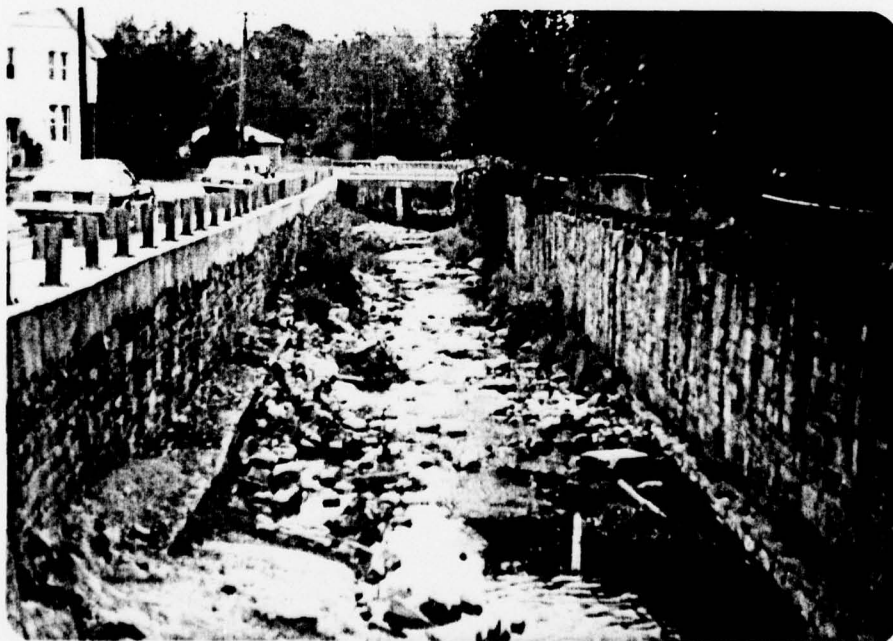
Photograph No. 10

Typical stream channel through Altoona.
